Case 364 : Narrative

Case Vehicle (A): 1998 Ford
Type: Windstar GL, 4 x 2, minivan
Driver: 44- year-old female
CDC: 12-FREE-9, 12-FLEE-9

CASE NO.: 364-03

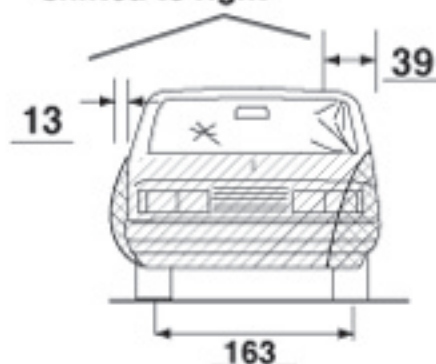
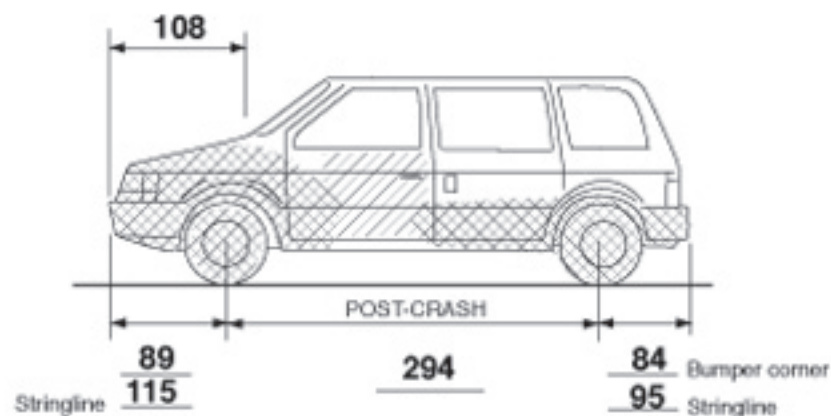
Front bumper corners
shifted to right

Max. crush to right
front bumper corner
from guardrail impact

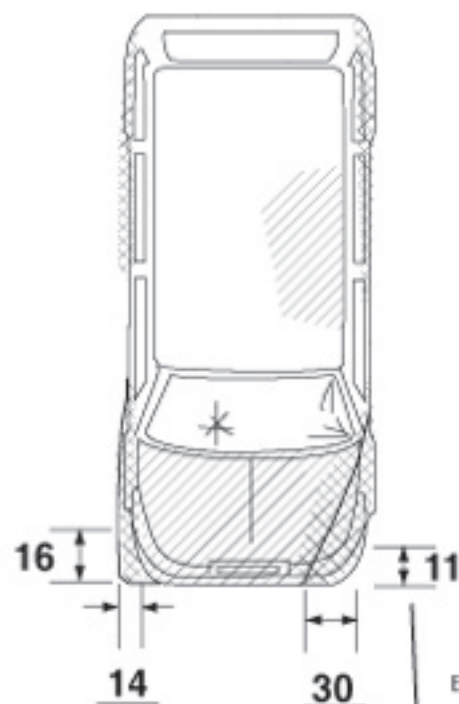
Width of direct damage
to front from guardrail and
concrete barrier impacts

Max. crush to left front bumper corner
from concrete barrier impact

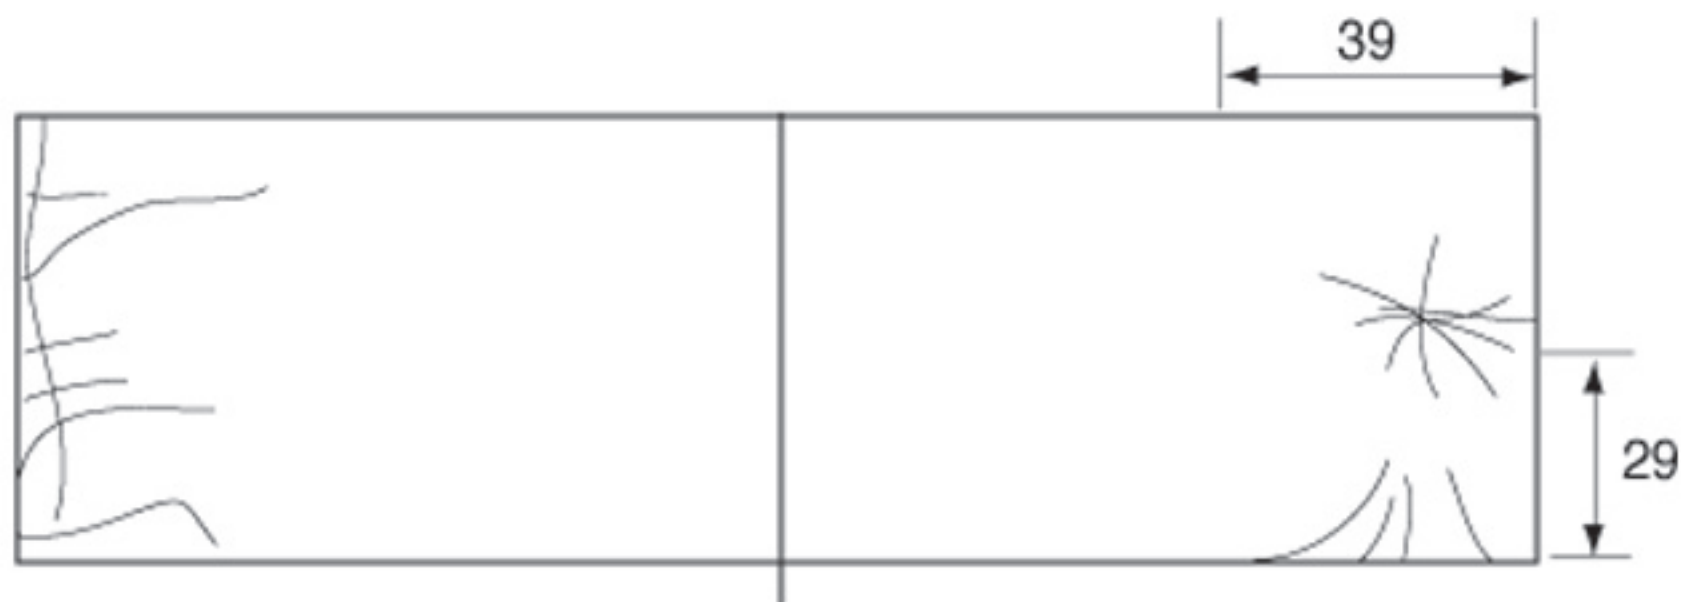
Windshield cracked on left due to upper left A-pillar and roof deformation, cracked on right due to passenger airbag deployment

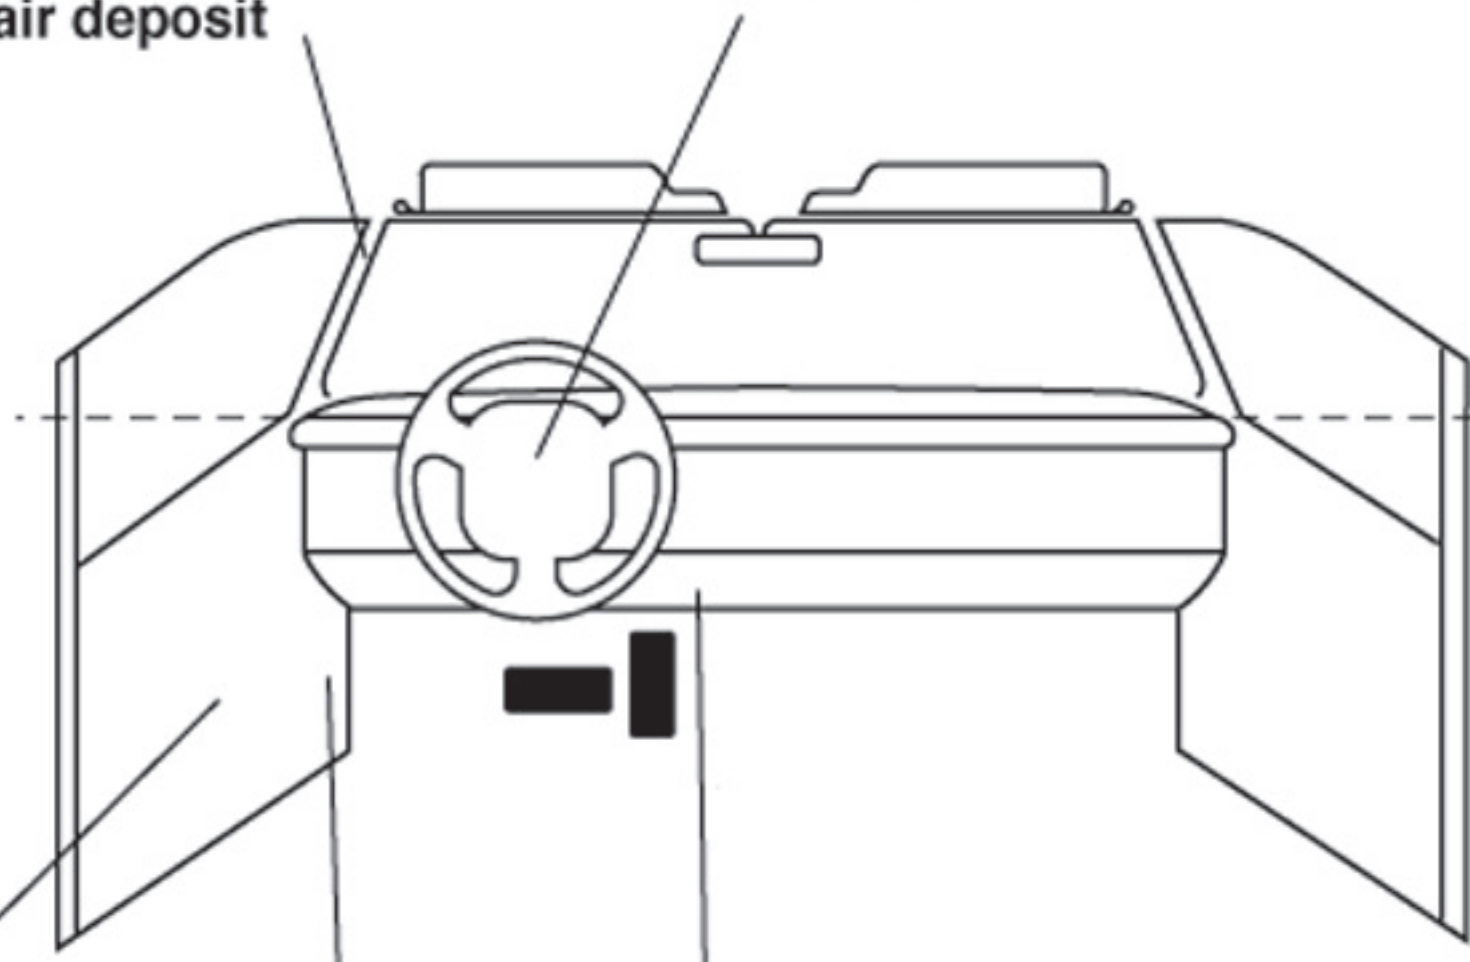
**D = upper A-pillar,
scuffmark, blood and
hair deposit**

**E = steering column,
deflected to left**
